**THE PUBLIC HEALTH RISK OF PATHOGENIC
BACTERIOLOGICAL CONTAMINATION OF WATER IN THE
KAFUBU RIVER**

A research report submitted in partial fulfillment of the requirements for the award of the
Master's Degree in Disaster Studies of Mulungushi University

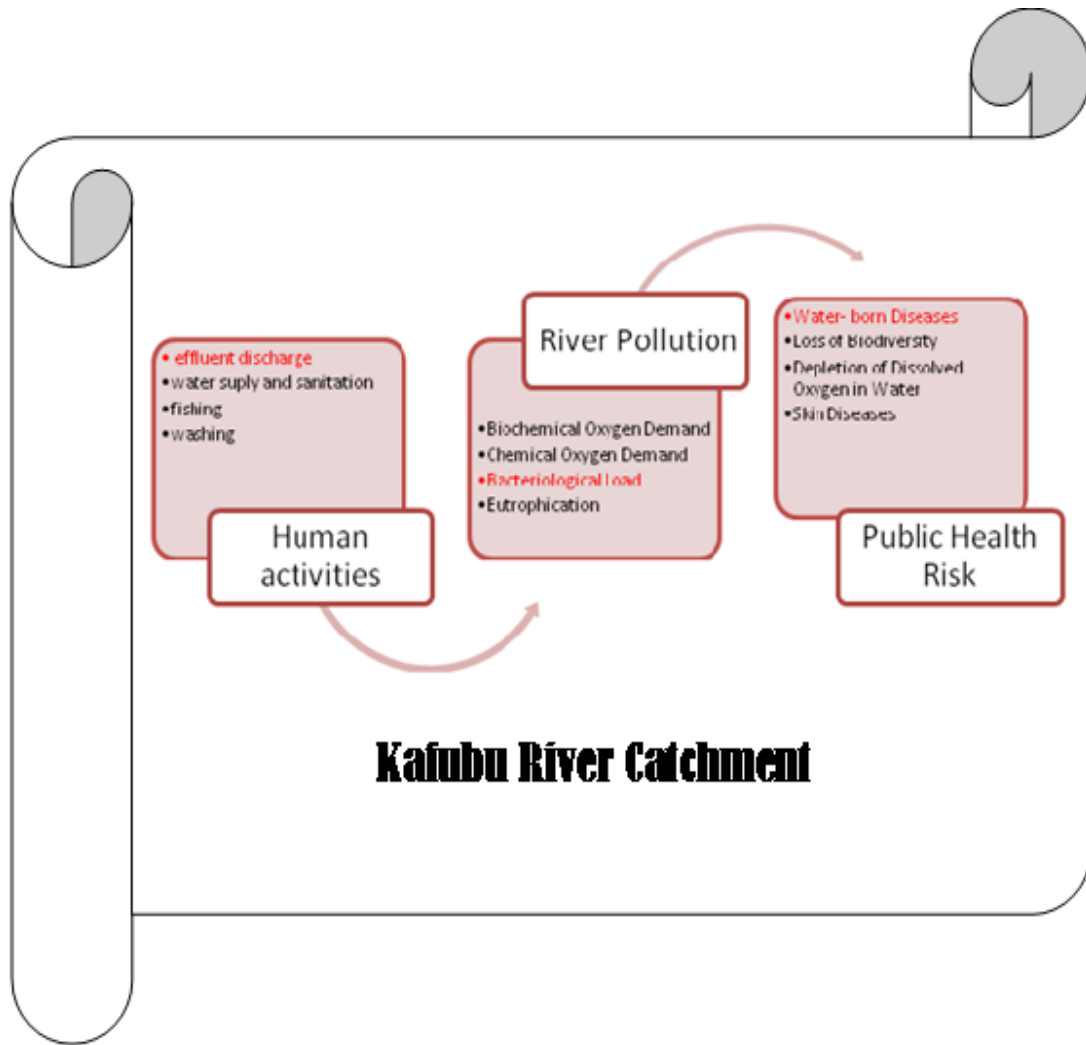
Figure 1: Conceptual framework for assessing the public health risk of bacteriological contamination of the Kafubu River, Zambia

Human activities can lead to an increase in microbial contaminants in the river which can lead to river water contamination and hence threaten the public health as shown in (**Figure. 1**), because surface water can work as a transmitter of diseases and so human health may be compromised as a result of contaminated water used as a source of domestic, agricultural, industrial, fishing and recreational water (Oliver *et al*, 2005). Therefore, an assessment of water quality of such a river system can be of great importance to ascertain its quality.

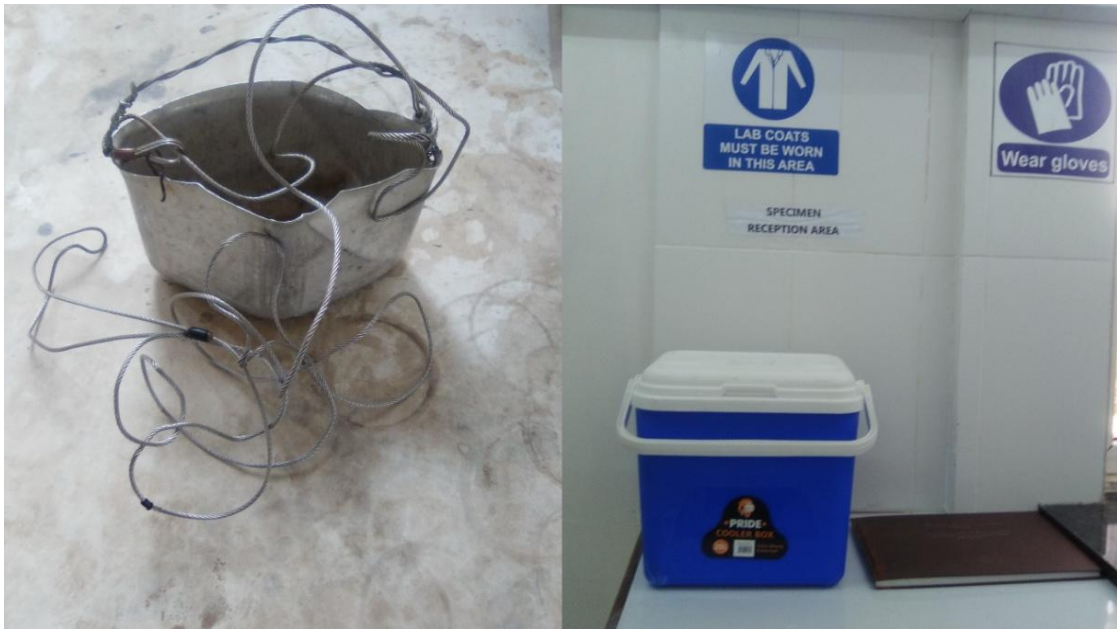
Figure 4: sampling scoop with 2.5m rope left and cooler box right used during sample collection

Grab samples of water were collected from the ten (10) sampling points on the Kafubu River using a sampling scoop tied to a 2.5-metre steel rope (Figure 4). Borosilicate 500 ml glass bottles were used during sample collection (Figure 5). Sample bottles were sterilized for every batch to avoid sample contamination. Methylated Spirit and cotton wool were used to flame the sampling scoop to maintain integrity and avoid cross-contamination from one sampling point to another during the sampling process. Samples were put in ice packs during transportation to TDRC and KWSC laboratories for analysis.

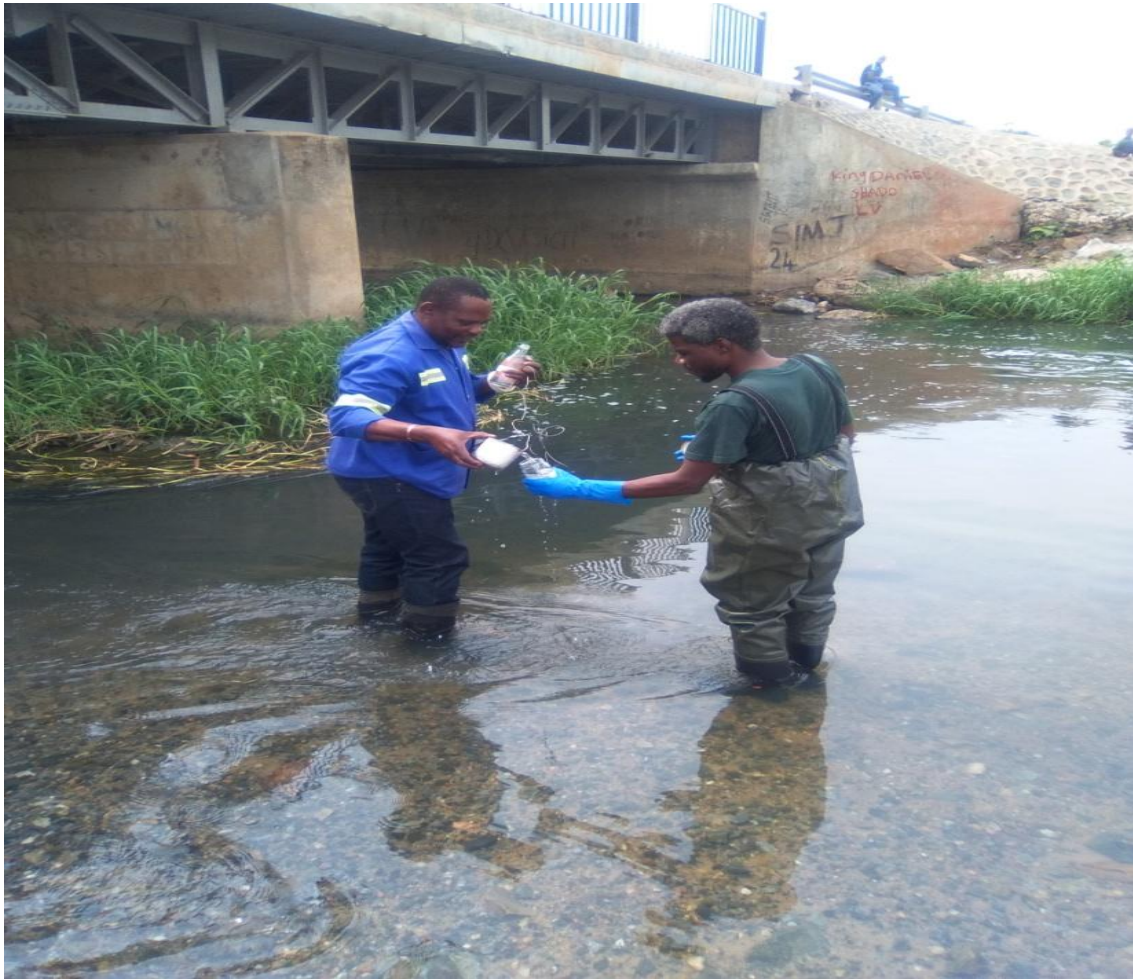
Figure 5: sampling process in progress at sp-7

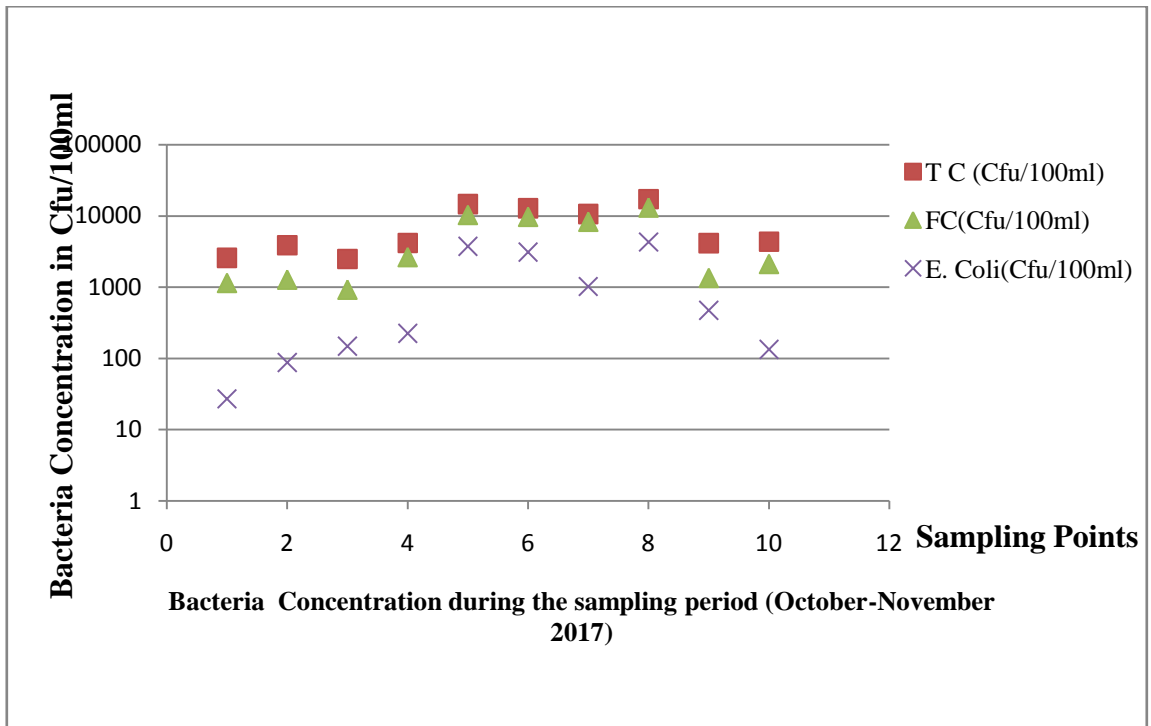
Figure 7: the mean concentration levels of TC, FC and E. coli for all ten sampling points.

The means of the total coliforms (TC), fecal coliforms (FC) and the *Escherichia coli* (*E. coli*) were presented in (Figure. 7). The minimum mean for TC was 2497 cfu/100ml and the maximum mean was 17101 cfu/100ml of water sample. The minimum mean for FC was 925cfu/100ml and the maximum mean was 13083 cfu/100ml of water sample. The minimum and the maximum means of FC were far from the freshwater quality standard limits and this confirmed the high concentration level FC in Kafubu River. The minimum mean for *E. coli* was 27 cfu/100ml and the maximum was 4302 cfu/100ml of water sample. The means from sampling points 1, 2 and 4 were in conformity with the freshwater quality standard limits for *E. coli* and sampling points 3 and 10 were partially in conformity with the freshwater quality standard limits as shown in figure 7. Sampling points 5,6,7,8 and 9 confirmed high concentration level of *E.coli* in the Kafubu River.

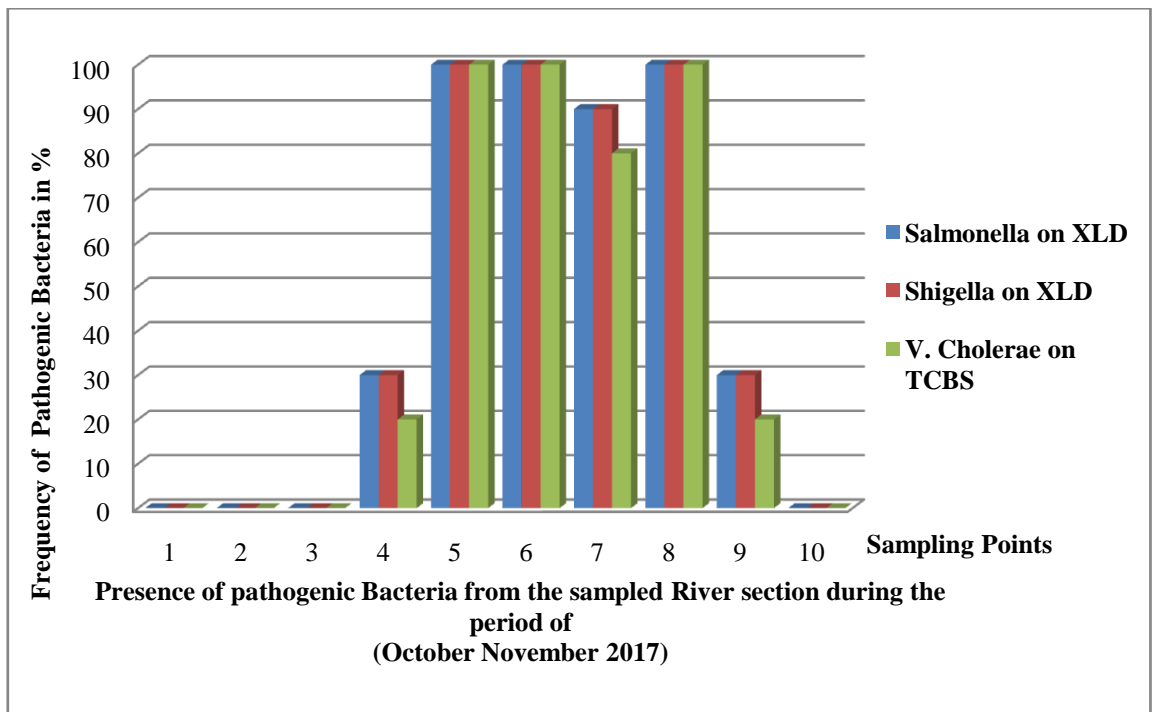
Figure 8: presence of pathogenic bacteria in ten sampling points

The presence in percentage of the three pathogenic bacteria in Kafubu River was examined and the findings were shown in Figure 8. *Salmonella*, *Shigella* and *Vibrio cholerae* were dominantly present in sampling points 4, 5,6,7,8 and 9. Sampling points 5, 6 and 8 scored the highest percentage being 100% for all the three pathogenic bacteria. Sampling points 4 and 9 scored 30% *Salmonella*, *Shigella*, and 20% for *Vibrio cholerae* respectively. Sampling point 7 scored 90% for both *Salmonella* and *Shigella* and 80% for *Vibrio cholerae*. Sampling point 1, 2, 3 and 10 recorded 0%.

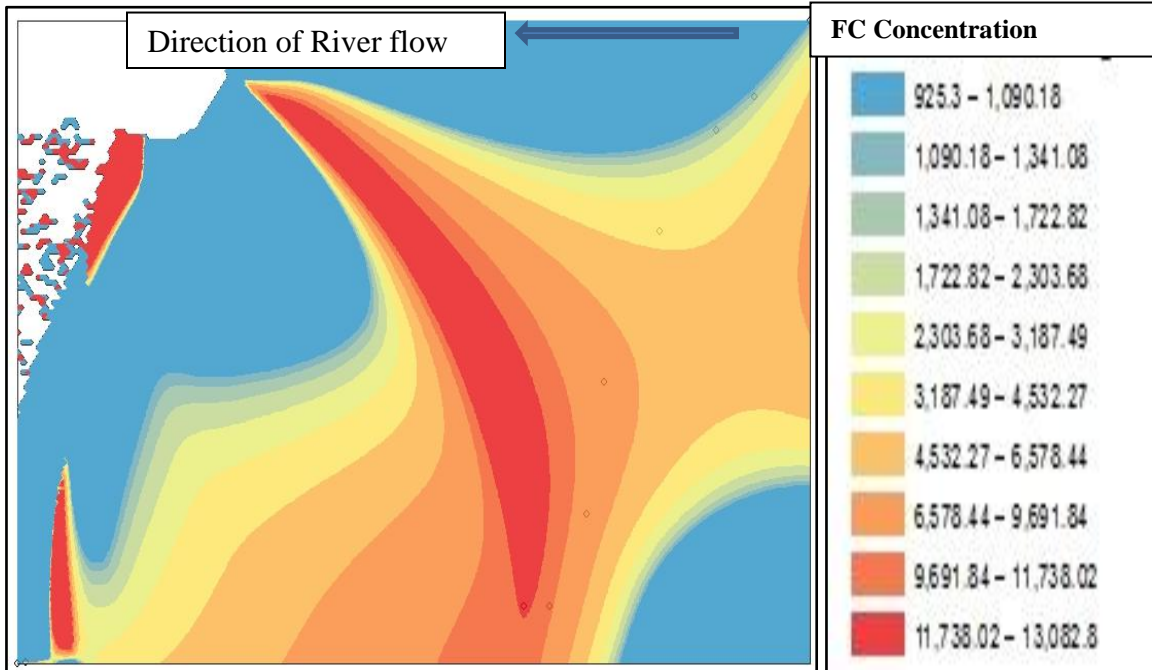
Figure 10: fecal coliforms spatial distribution of the concentration level of contamination

The arrow in Figure 10 is showing the River flow direction. The change in color is showing the change in concentration level of contamination of fecal coliforms in the Kafubu River. The blue color is showing the lowest concentration and the red color showing the highest concentration of the fecal coliforms in the River.

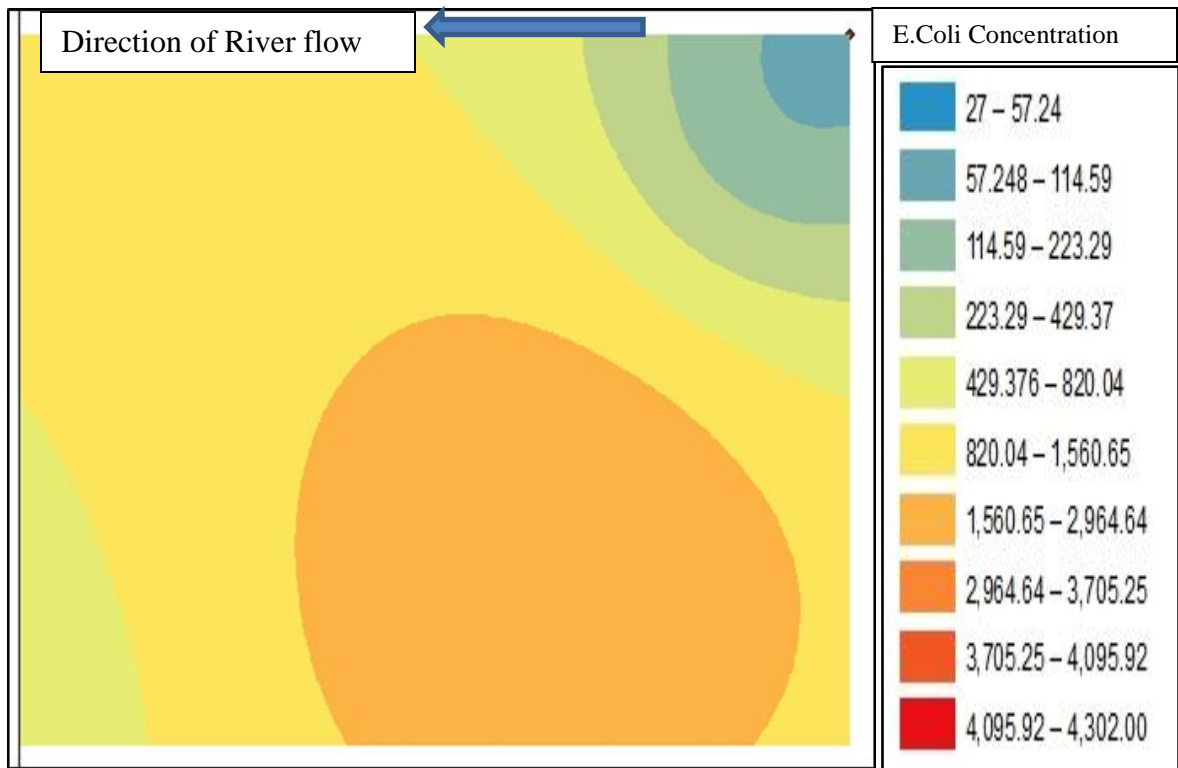
Figure 11: Escherichia Coli spatial distribution of the concentration level of contamination

The arrow in Figure 11 is showing the River flow direction. The change in color is showing the change in concentration level of contamination of *Escherichia Coli* in the Kafubu River. The blue color is showing the lowest concentration and the red color showing the highest concentration of the *Escherichia coli* in the River. The deep red color is not seen in Figure 11 due to being overlaid.

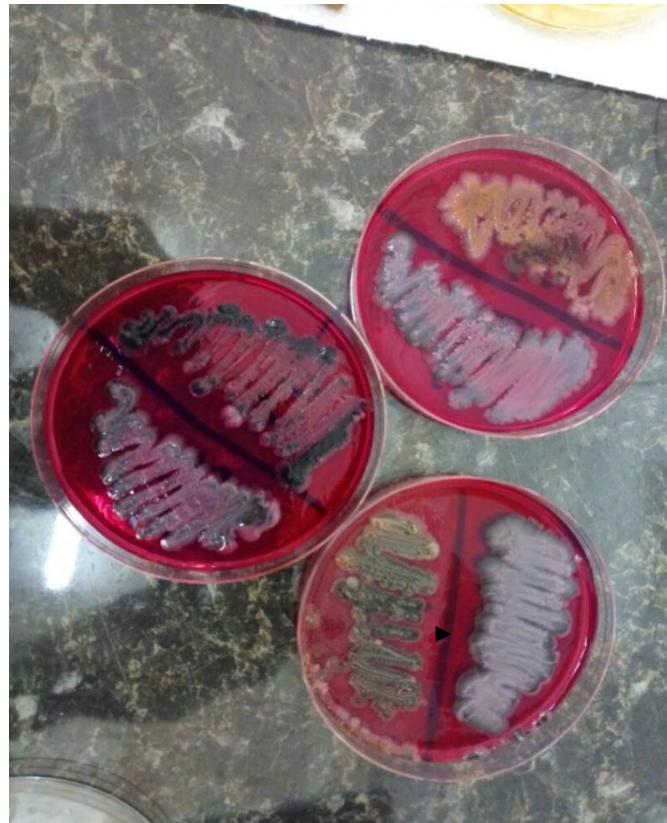
Black spots indicating production of Hydrogen Sulphide by *Salmonella*

Yellowish color showing the *Escherichia Coli* on XLD

Reddish color Showing the presence of *Shigella*

Figure 18: presence of *Salmonella* and *Shigella* on XLD

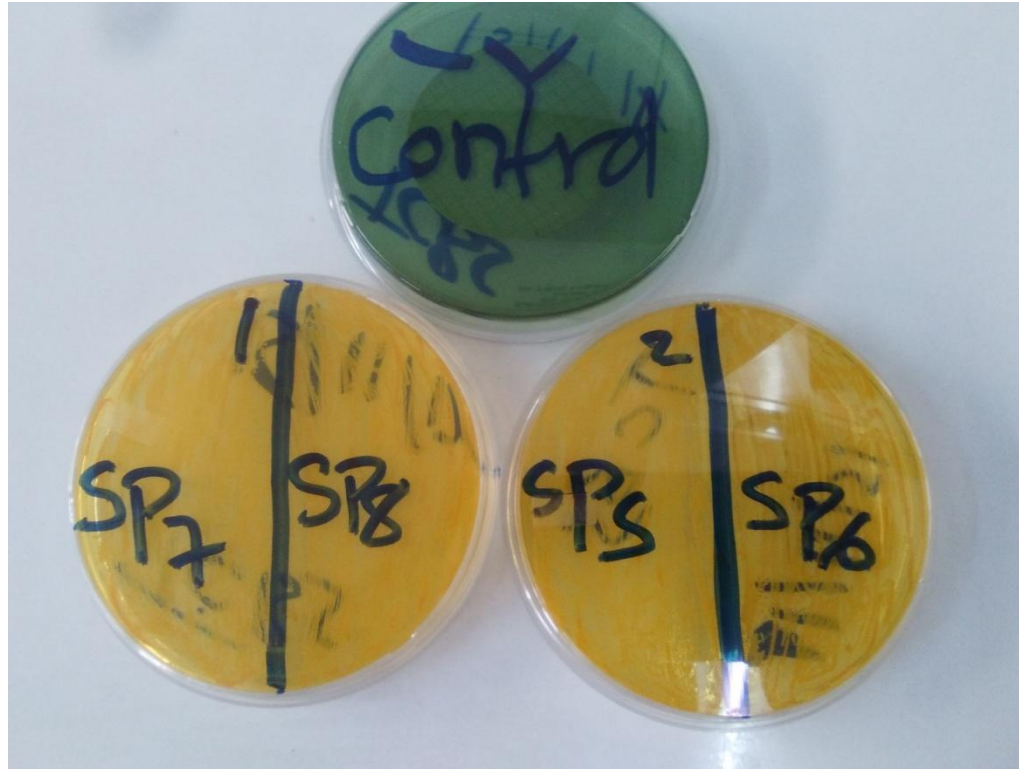
Figure 19: negative control plate and the positive water sample plate for *Vibrio Cholerae* on TCBS
